Manhole Inspection Summary

Manhole # S21II_033MH

Insp Date: **6/22/07 12:03 PM**

Location Address: **1700 MCKEAN-FULTON** Cross Street: **PRESBURY ST**

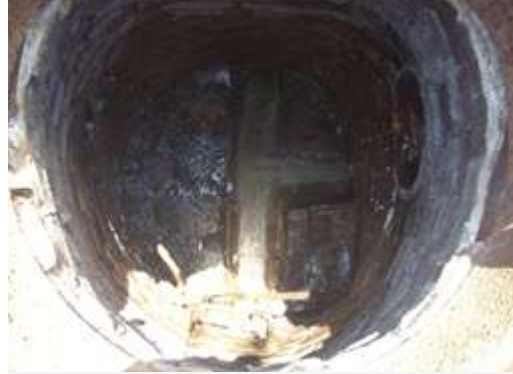
Top View

Comments **major infiltration of barrel, huge hole on corbel**

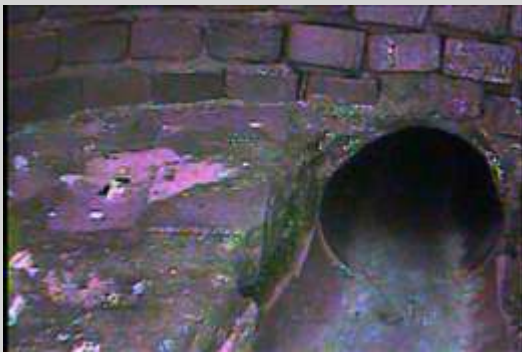
12 O'Clock Outflow

10 in. Circular Gravity Sewer
Pipe Out @ 12 O'Clock

Pipe Height: **9.6** (in.) Rod and Bar (Angled)
Pipe Material: **Clay** ☐ Pipe Lined
Invert Depth: **9.30** (ft.) Flow Characteristics: **Fast**
Deposits: ☒ None ☐ Mud ☐ Sludge ☐ Debris ☐ Grease
Silt Depth: (in.) Deposits Extent:
Infiltration: **None** Pipe Seal Cond: **Sound**

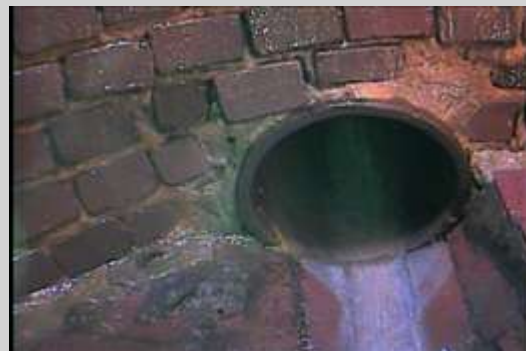
Drop In @ 3 O'Clock

Drop: **Outside** Rod and Bar
Angled: **Yes** Reading: **7.59** (ft.)
Inv Depth: **8.59** (ft.)
Drop Condition: **Open**

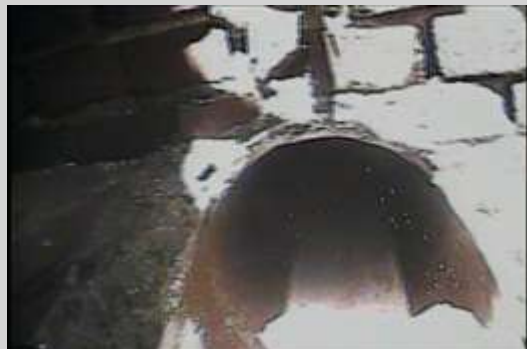
6 O'Clock Inflow

10 in. Circular Gravity Sewer
Pipe In @ 6 O'Clock

Pipe Height: **10.8** (in.) Rod and Bar (Angled)

Infiltration: **None** Pipe Seal Cond: **Sound**
